OPERATION AND MAINTENANCE MANUAL

LONGVIEW LAKE

APPENDIX IV

CONSTRUCTION FOUNDATION REPORT

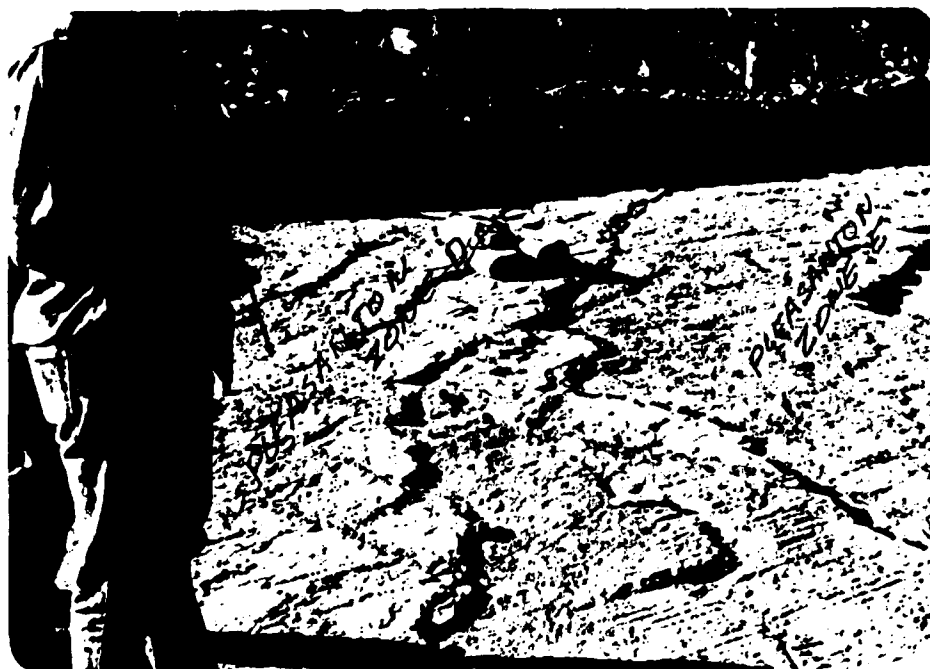
1. Longview Lake, 4 Dec 79, Neg. No. 1.
Left side outlet works excavation Station 50+77 to
to Station 50+87. Pleasanton Formation zones D and E.

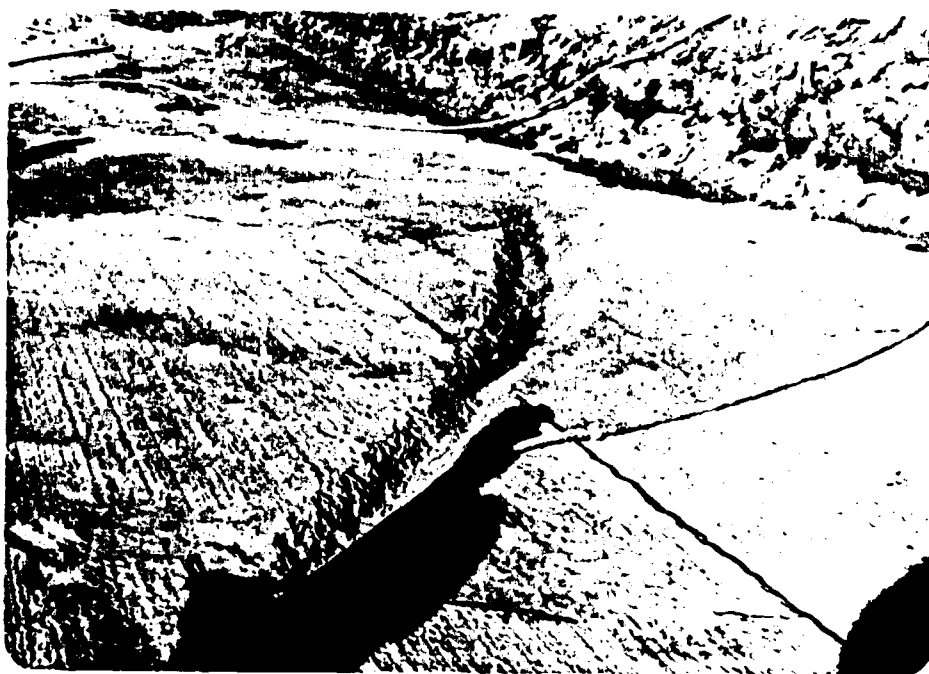
3. Longview Lake, 4 Dec 79, Neg. No. 4.
Look right and downstream outlet works excavation.
Station 51+14 to Station 51+33. Dozer blade mark.

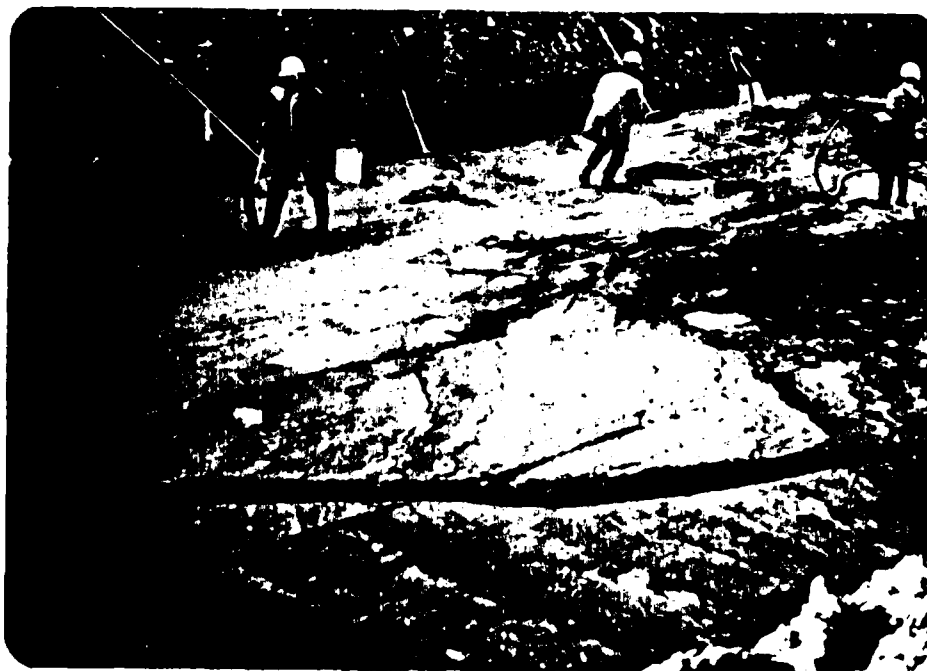
4. Longview Lake, 4 Dec 79, Neg. No. 5.
Look left and downstream. Outlet works excavation.
Station 51+14 to Station 51+33. Dozer blade mark.

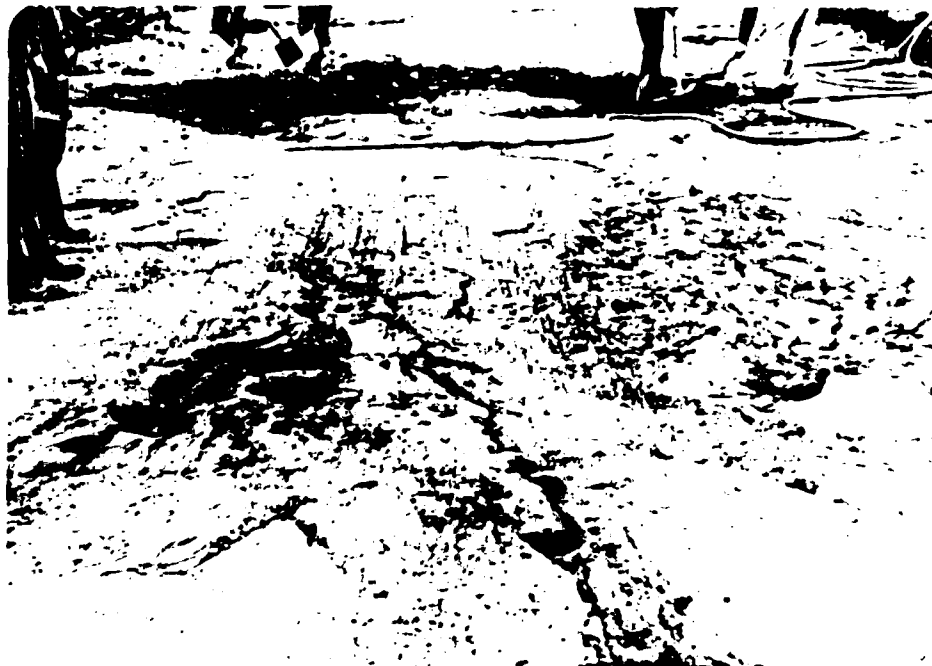
5. Longview Lake, 4 Dec 79, Neg. No. 6.
Look downstream. Outlet works excavation at
Station 51+20. Pleasanton Formation zone E.

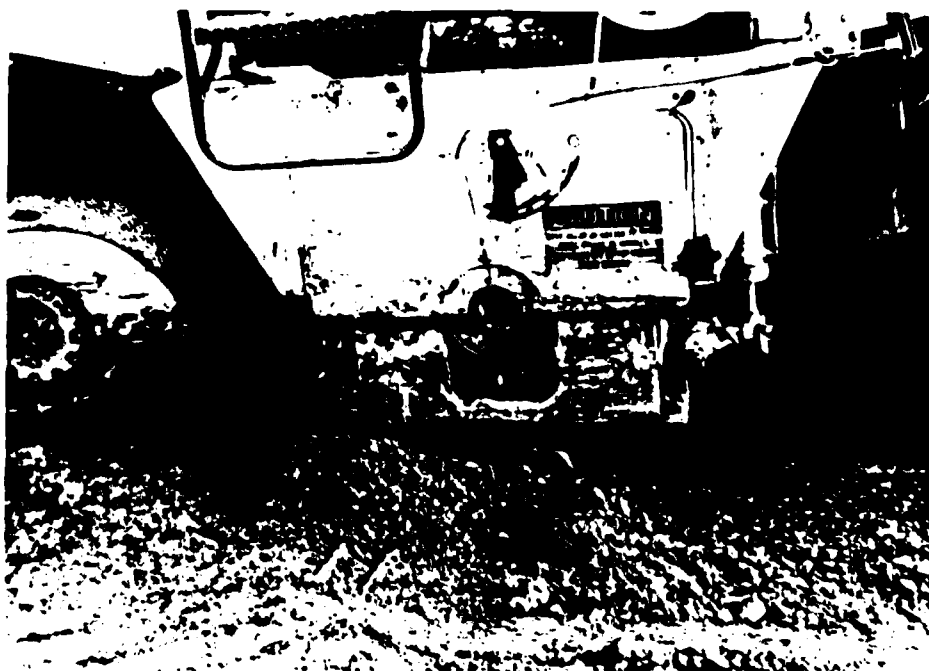
10. Longview Lake, 4 Dec 79, Neg. No. 13.
Track mounted "roto mill" used to excavate final
foundation surface.

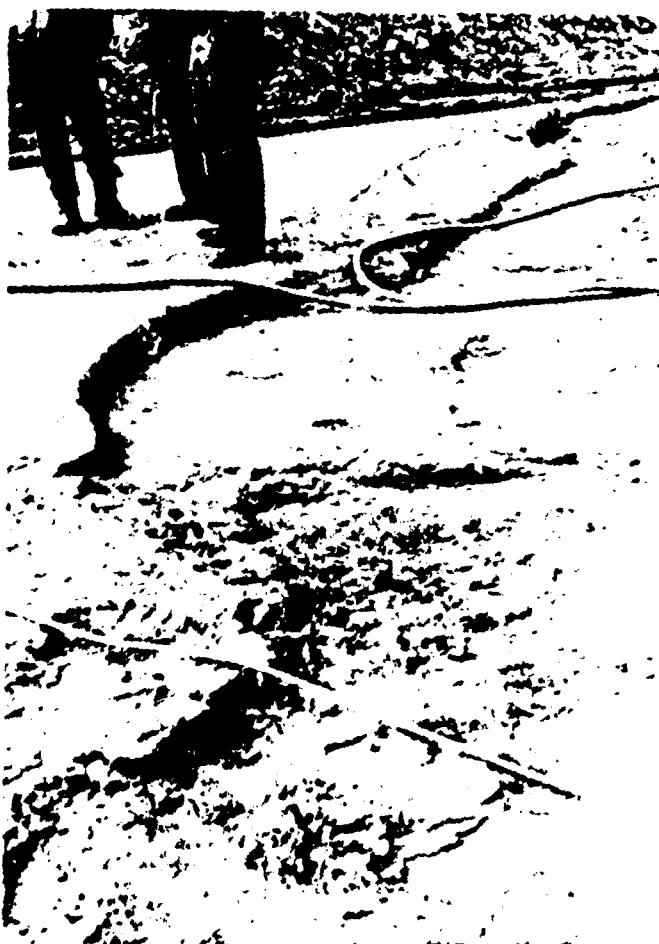
12. Longview Lake, 8 Dec 79,
Neg. No. 14.
Station 52+10, centerline.
Look left and downstream
Pleasanton Formation zone.

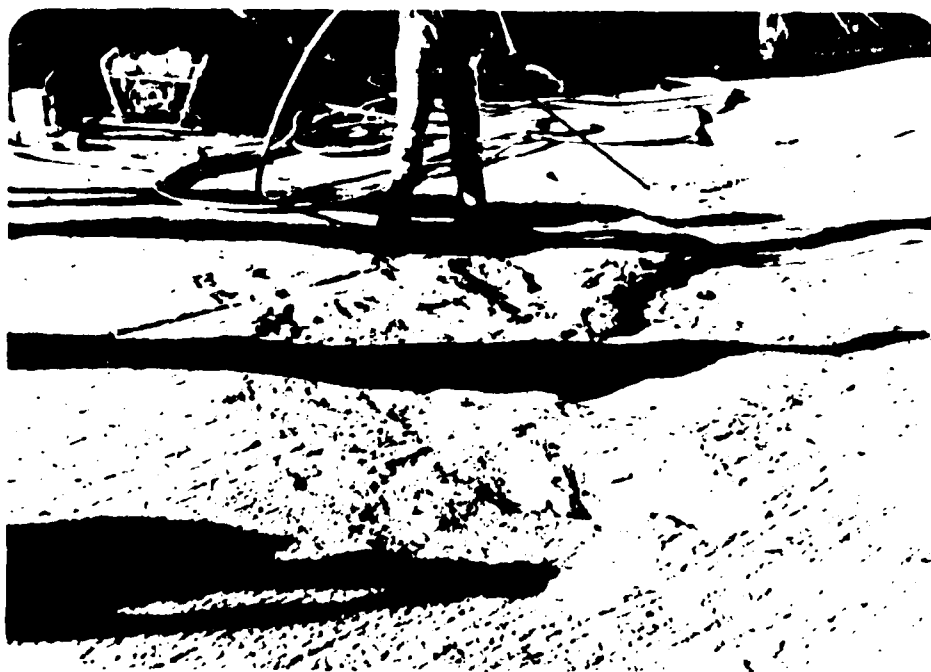
19. Longview Lake, 6 Dec 79, Neg. No. 26.
At Station 53+40, centerline. Look left and down-
stream. Pleasanton Formation zone E.

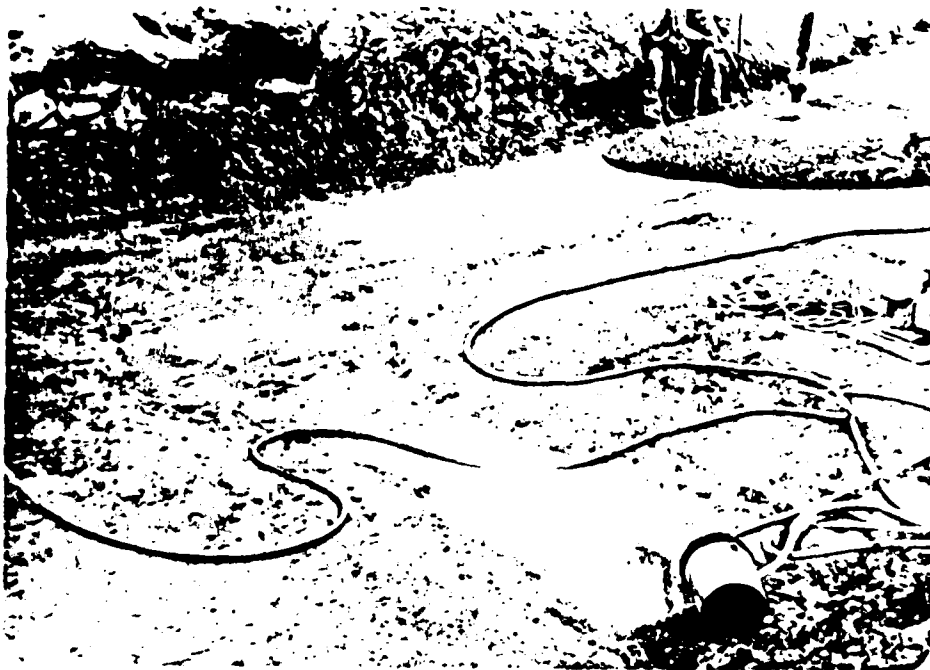
21. Longview Lake, 6 Dec 79, Neg. No. 28.
At left side Station 54+10. Look right and upstream.
Placing lean concrete.

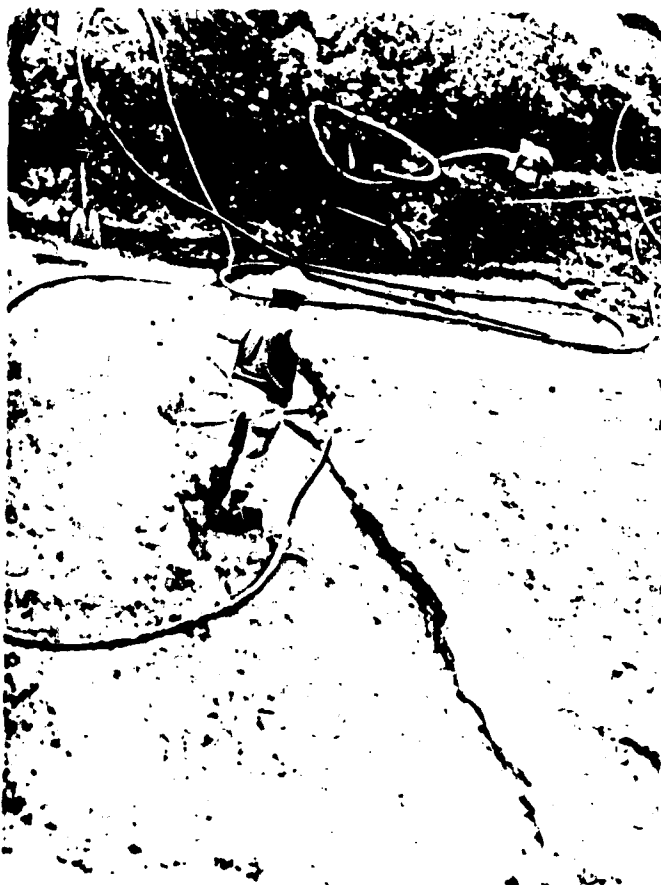
22. Longview Lake,
6 Dec 79, Neg. No. 29.
At right side Station
53+95. Look left.
Pleasanton Formation
zone E.

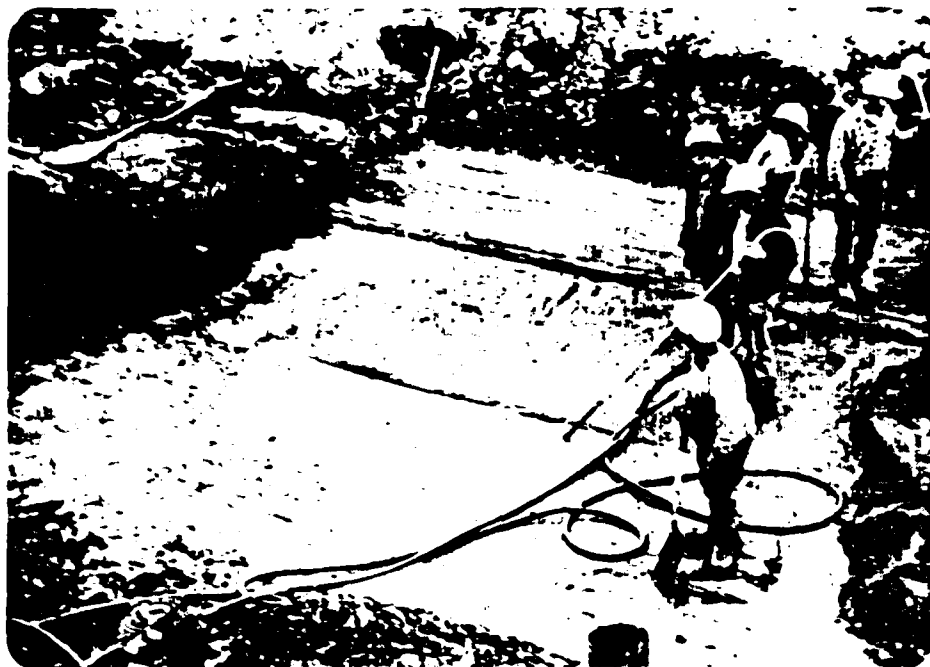
23. Longview Lake, 6 Dec 79, Neg. No. 30.
At left side Station 54+00. Look right.

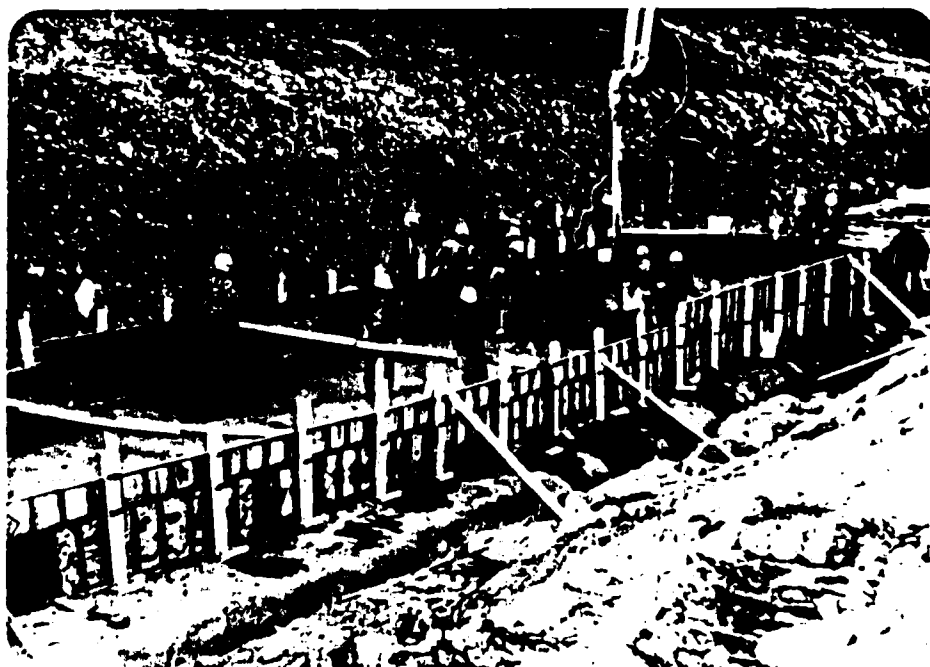
24. Longview Lake, 7 Dec 79, Neg. No. 32.
At right side Station 51+00. Look left and
downstream. Placing second layer of lean concrete.

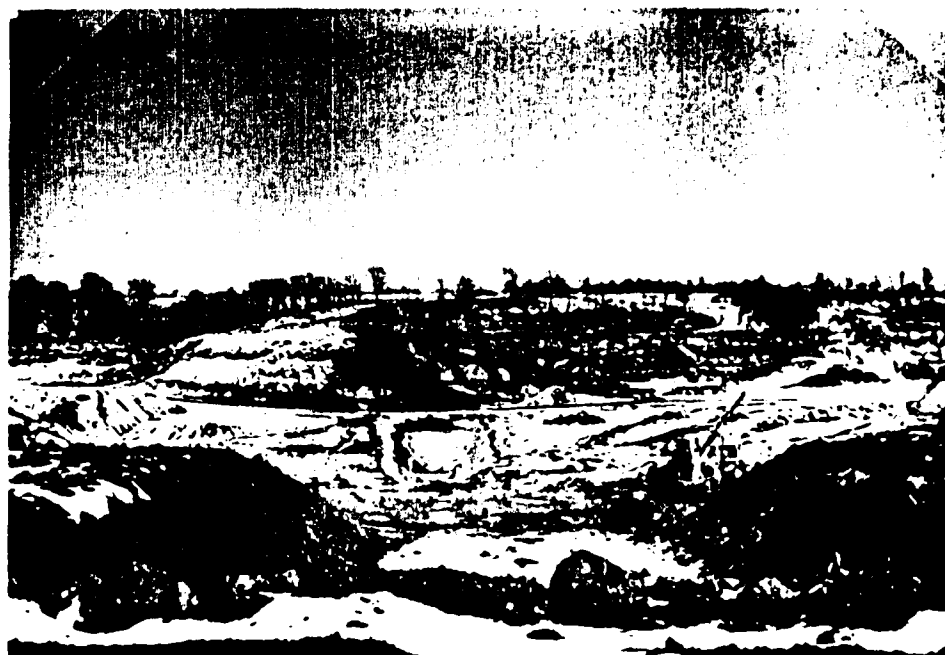
25. Longview Lake, 18 Feb 80, Neg. No. 33.
View of right abutment.

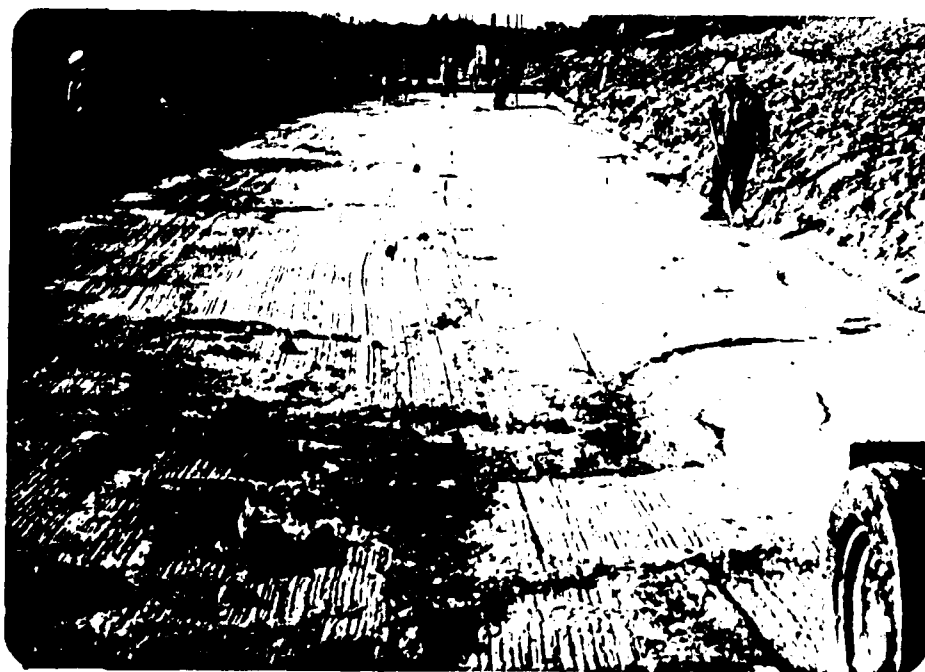
30. Longview Lake, 9 Apr 80, Neg. No. 115.
At Station 46+47, centerline. Look downstream.
Pleasanton Formation zone D.

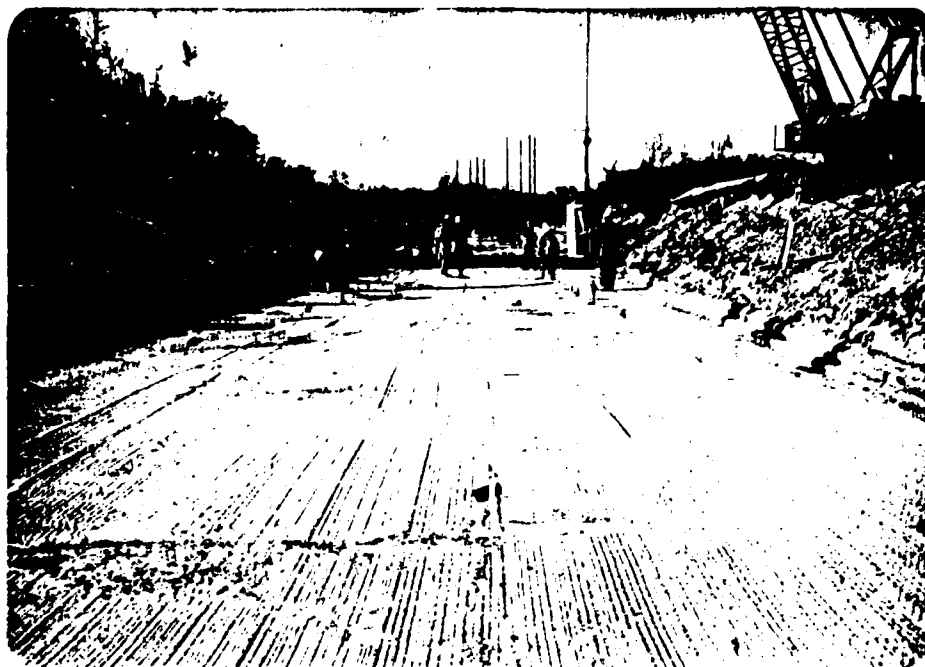
31. Longview Lake, 9 Apr 80, Neg. No. 116.
At Station 47+48, centerline. Look downstream.
Pleasanton Formation zone D.

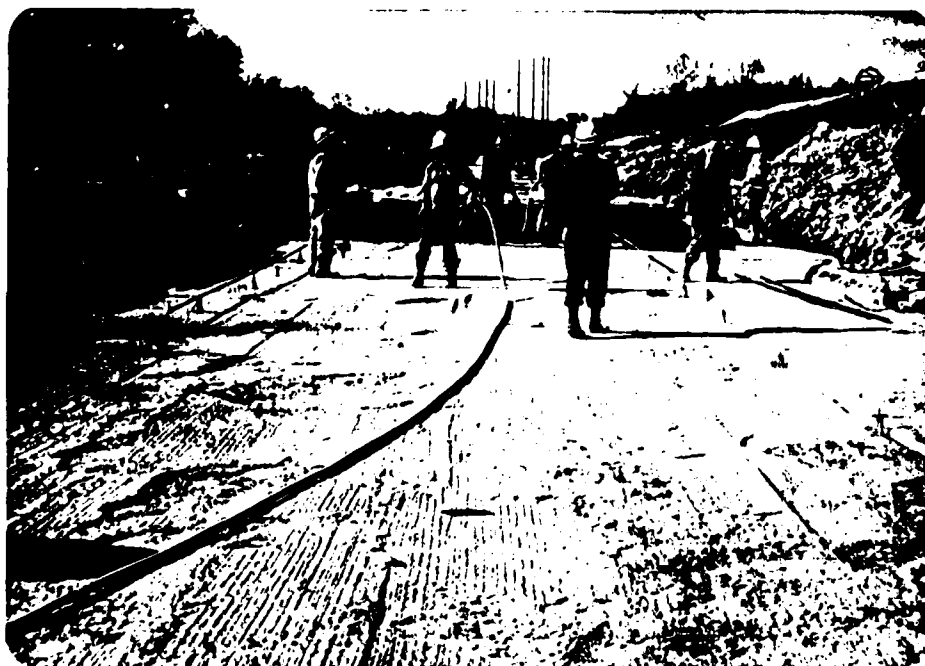
32. Longview Lake, 9 Apr 80, Neg. No. 117.
At Station 48+49, centerline. Look downstream.
Pleasanton Formation zone D.

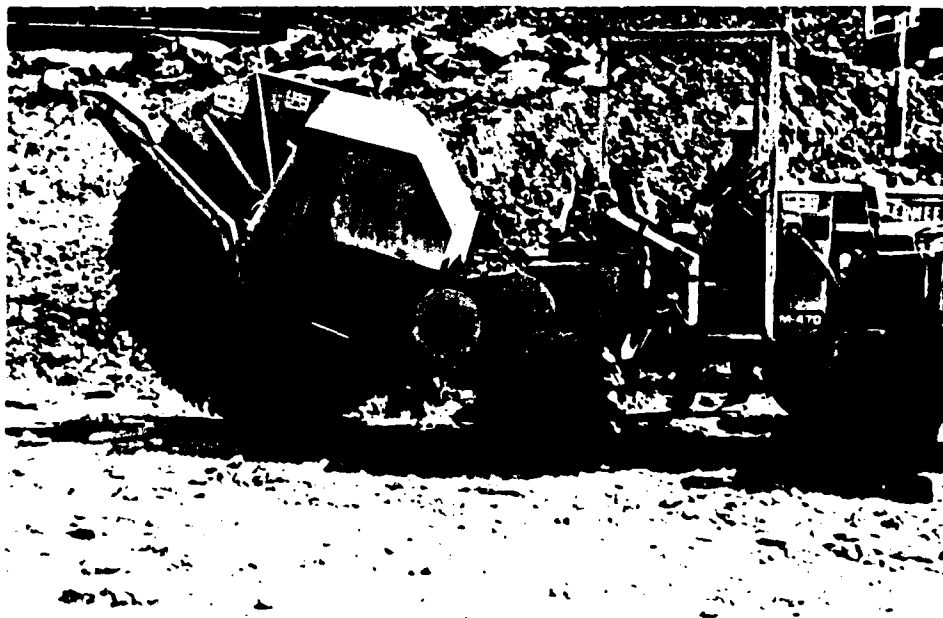
34. Longview Lake, 16 Apr 80, Neg. No. 123.
Rock saw used for vertical cuts in intake tower
area.

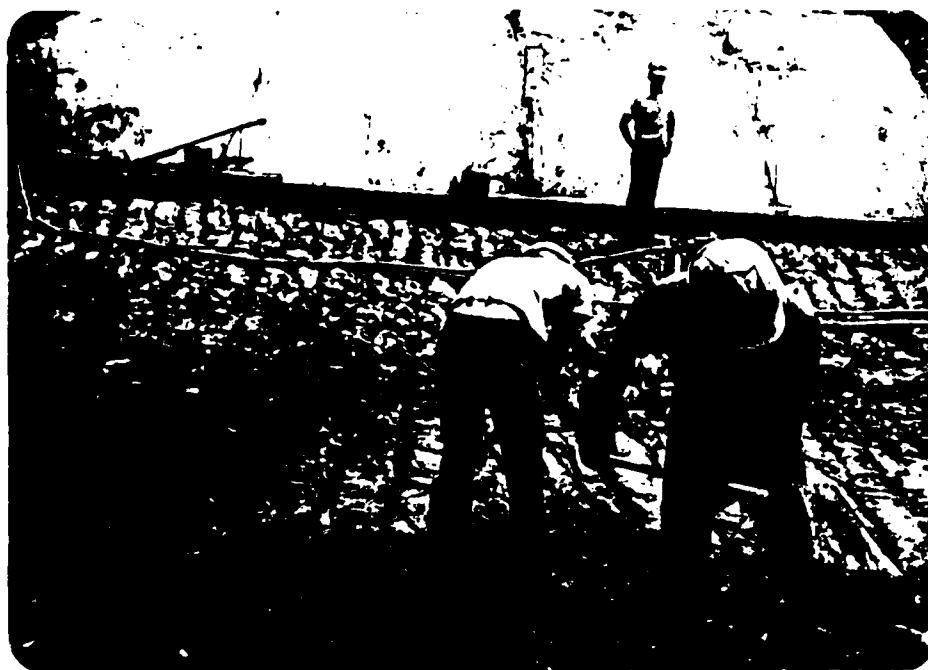
37. Longview Lake, 22 May 80, Neg. No. 165.
At Station 55+40, centerline. Look upstream.
Pleasanton Formation zone E.

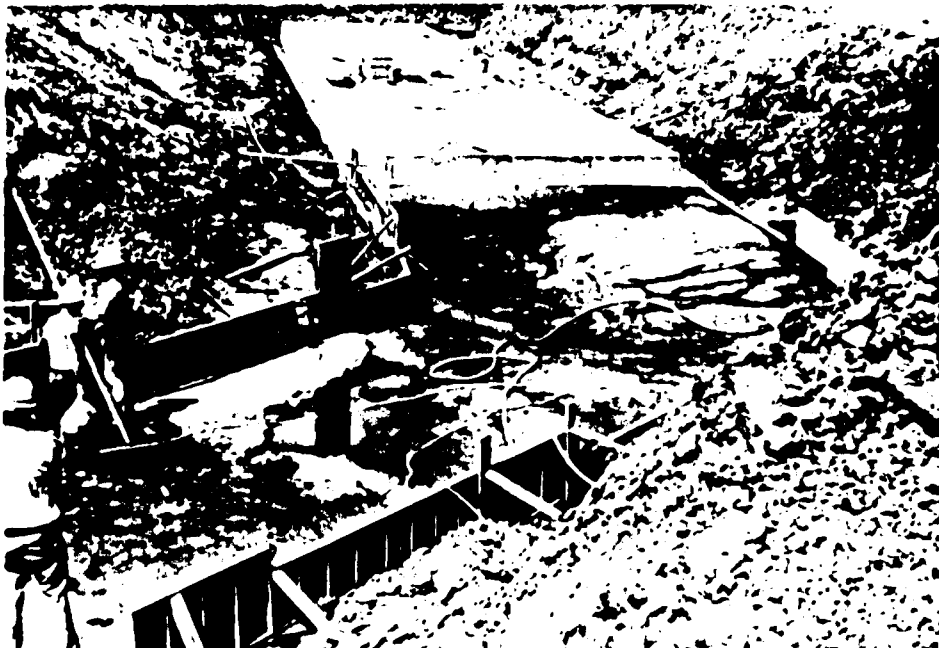
(d) Longview Lake, 22 Aug 80, Neg. No. 309.
 Camera at Station 54+50 range 70' right. Look
 upstream at "inverted siphon" sewer foundation.
 (Note construction road in foreground.)

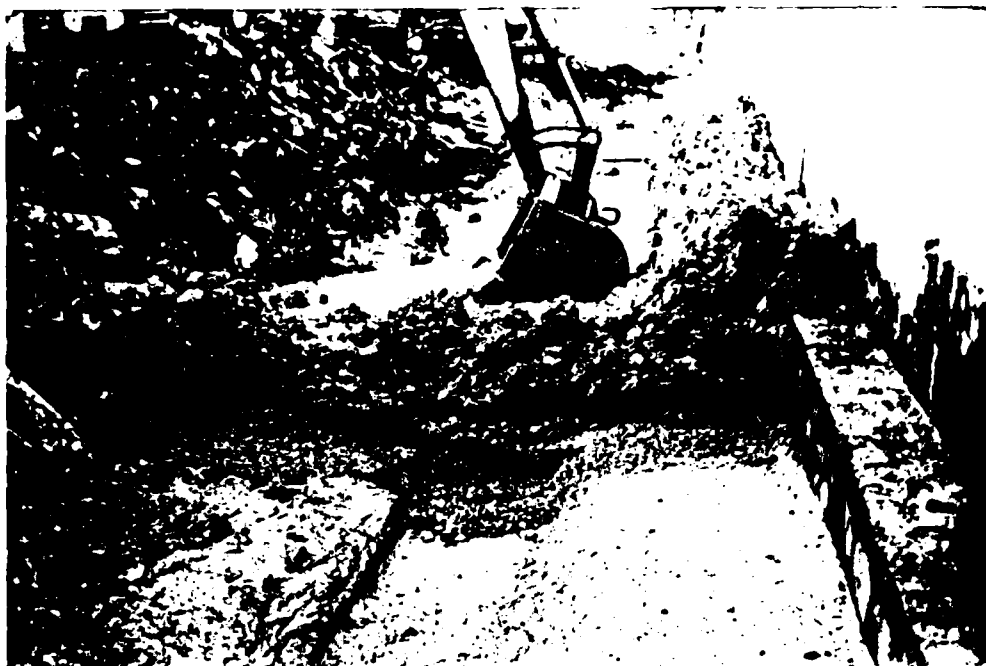
sl. Longview Lake, 28 Apr 81, Neg. No. 645.
O.W. Station 51+25 on left side. Look downstream.
Foundation cleanup. Pleasanton Formation zone 1.

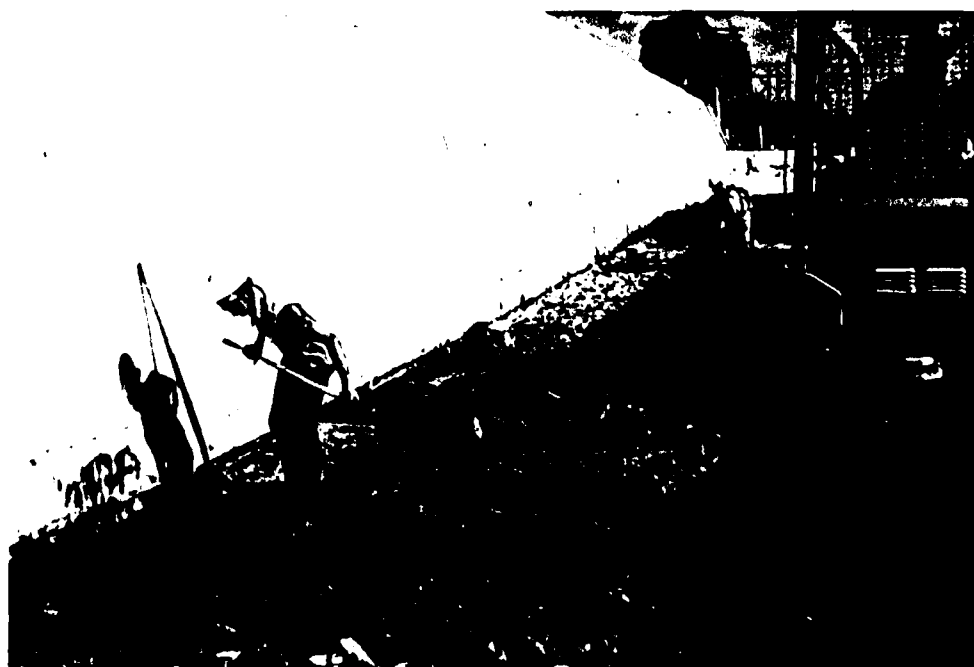
Longview Lake, 1 Jun 81, Neg. No. 706.
O.W. Station 52+35 on right side. Look downstream.
Foundation cleanup. Pleasanton Formation zone 1.

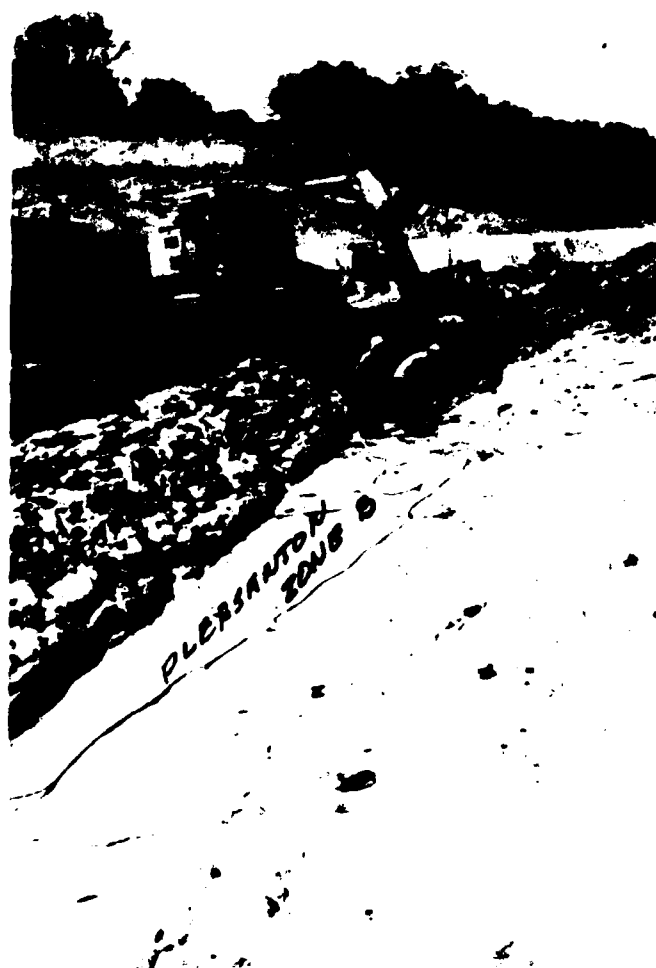
a. Valley section. All of the embankment foundation was stripped of boulders, sod, roots, tree stumps, etc., disked a minimum depth of 8 inches and compacted with a minimum of three passes of a rubber-tired roller. The existing 48-inch diameter RCP sewer pipe, which crossed the dam axis at station 97+95 was removed. The floor of the pipe excavation, (Pleasanton zone B shale), was cleaned with air-water jets. The vertical side slopes, (Pleasanton zone A sandstone), were, "trimmed back" to remove overhanging ledges. The pipe excavation was backfilled with compacted impervious clay. See photo 54.

54. Longview Lake,
Neg. No. 708.
O.W. Station 47+20±
road 180° right.
Look NW. Foundation
of old sewer
conduit. Pleasanton
Township, Jones A. 101.

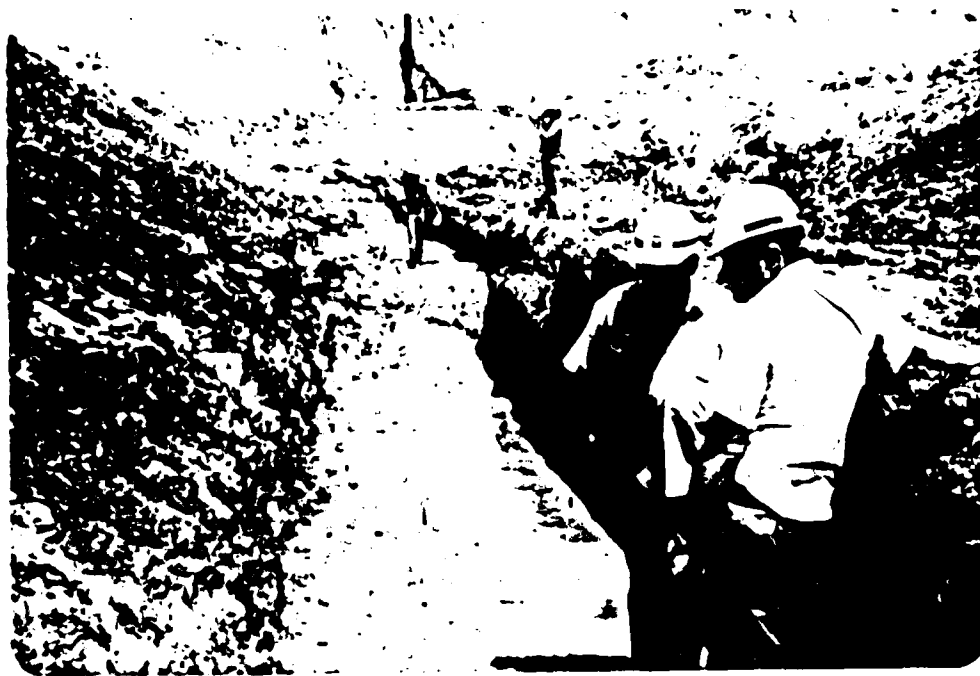
65. Longview Lake, 10 Jun 80, Neg. No. 22.
Cutoff trench Station 90+70, range 10' ± D/S. Look
southeast. Preparing for placement of pervious drain.

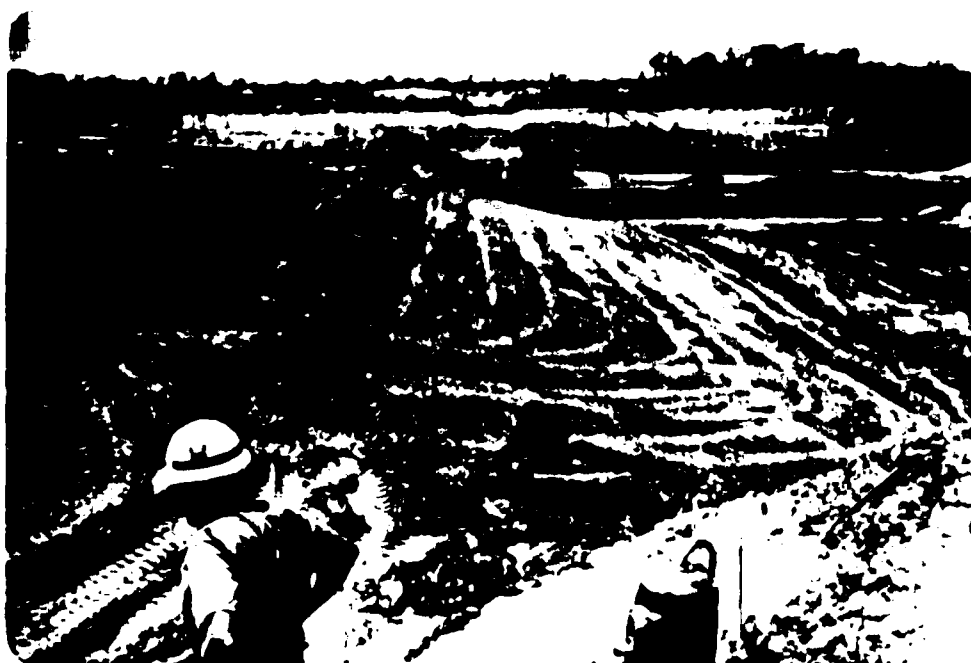
70. Longview Lake, 30 Jul 80, Neg. No. 239.
Look at cutoff and look at bottom of trench.

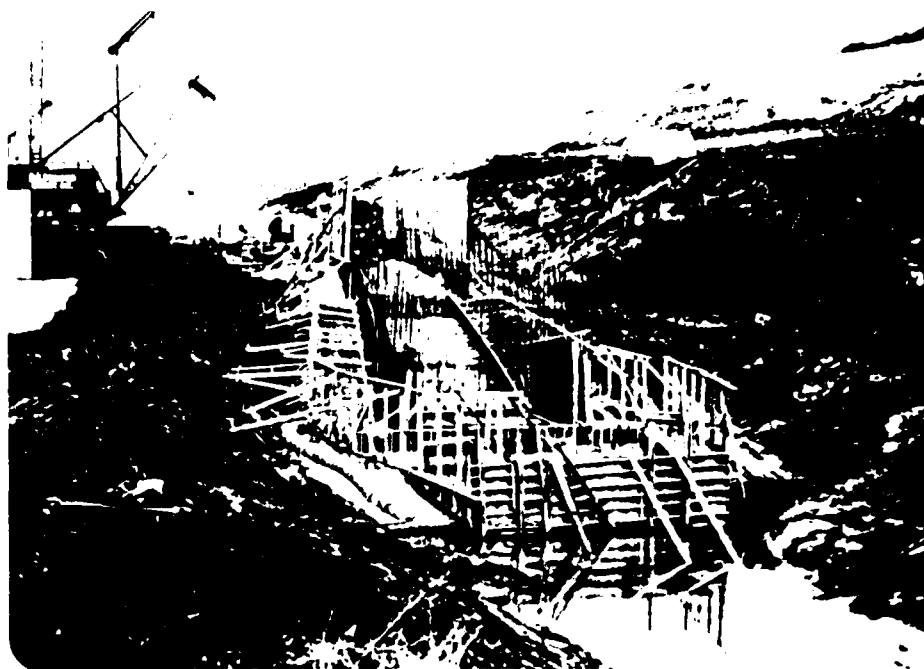
29. Longview Lake, 17 Nov 80, Neg. No. 403.
Look upstream at outlet works construction.

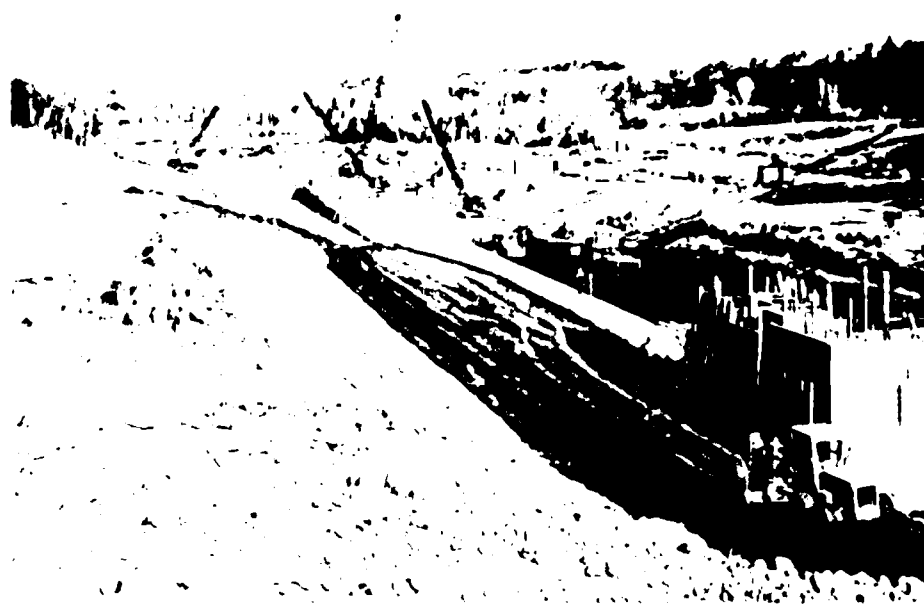
30. Longview Lake, 18 Nov 80, Neg. No. 426.
Look downstream at outlet works construction.

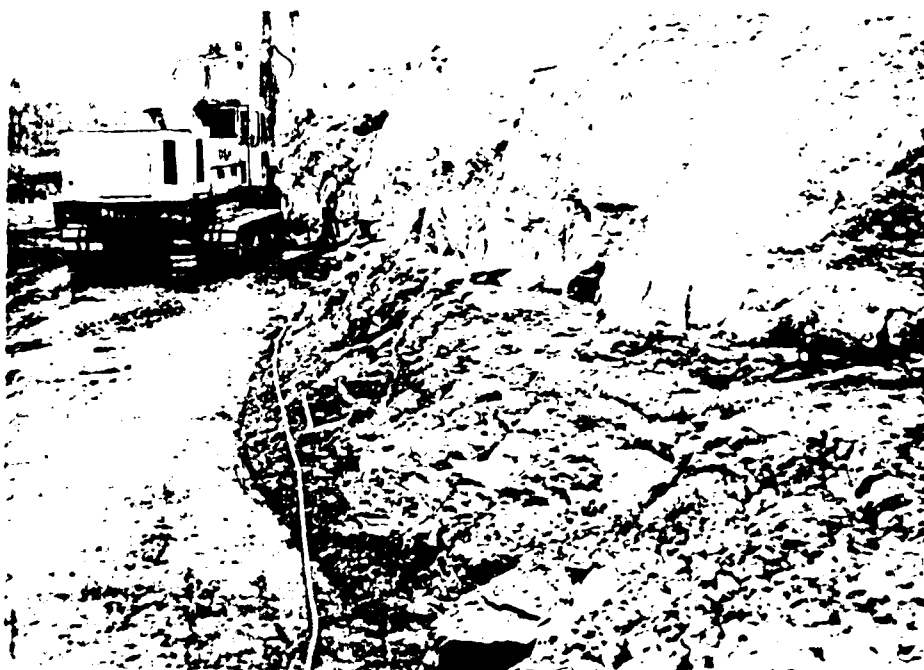
82. Longview Lake, 15 Dec 80, Neg. No. 467.
Station 87+80. Look downstream at Bethany Falls
LS and Hushpuckney Shale.

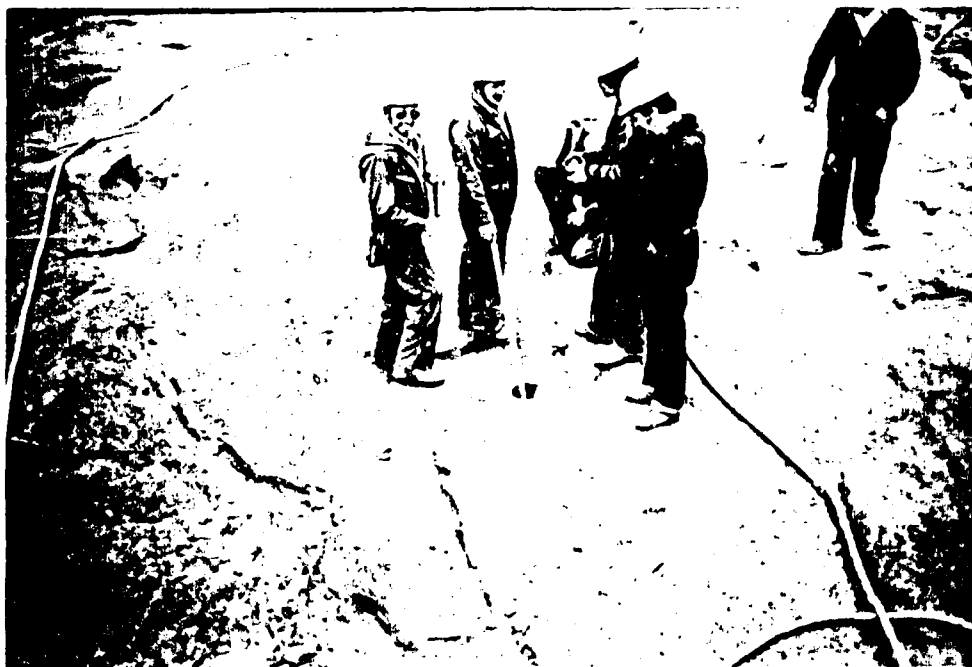
87. Longview Lake, 4 Apr 81, Neg. No. 613.
Station 97+95. From old 48-inch sewer look east
at 6-inch core hole AC-21. Pleasanton zone D.

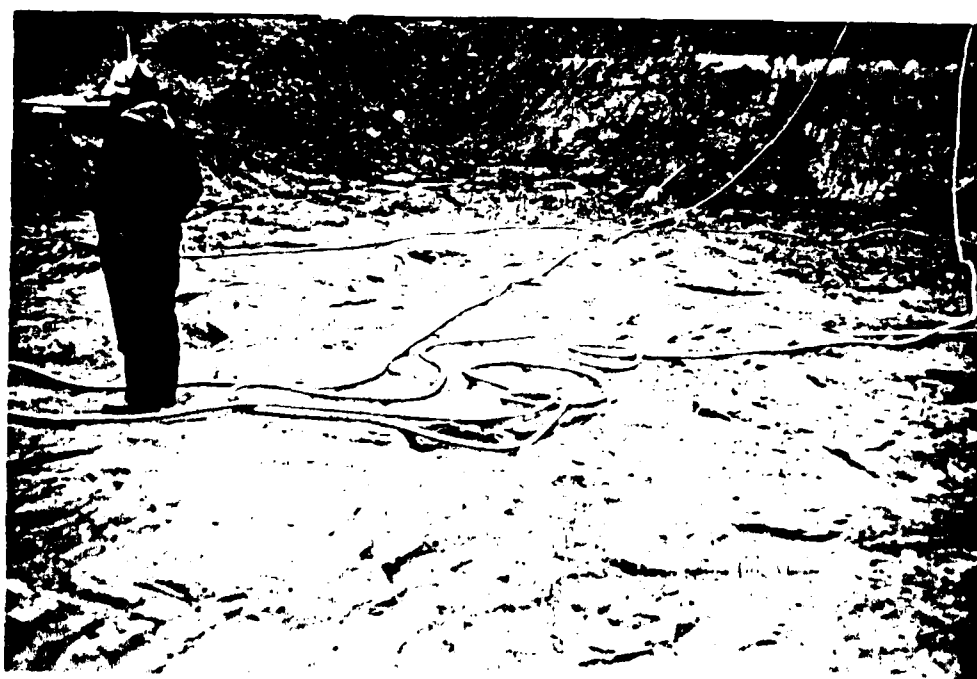
90. Longview Lake, 4 Apr 81, Neg. No. 617.
Station 97+65. Look west at old 48-inch sewer
pipe at Station 97+95.

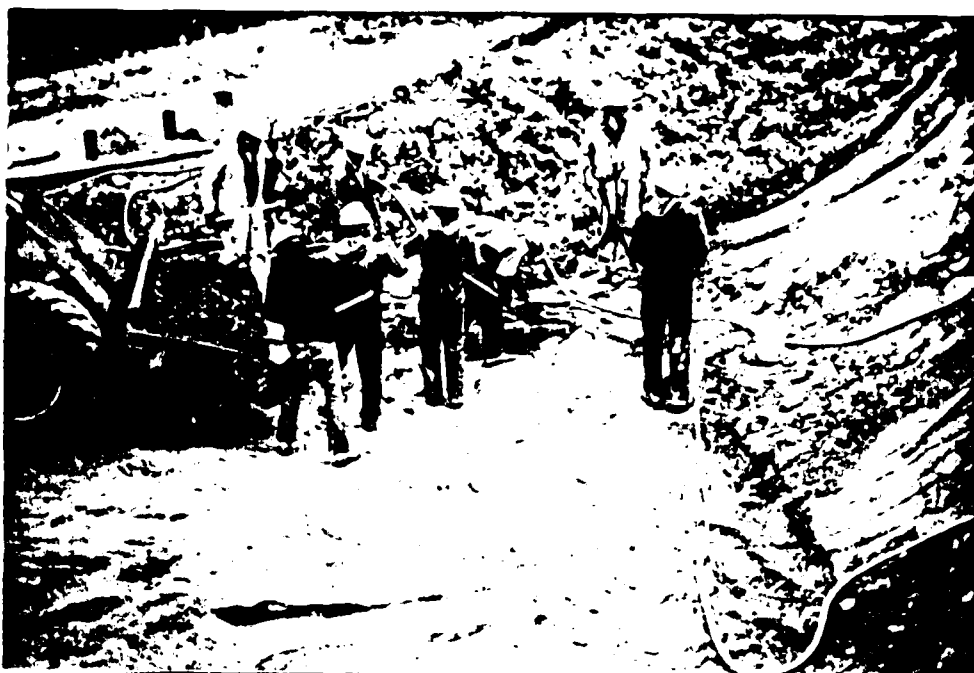
93. Longview Lake, 4 Apr 81, Neg. No. 620.
Station 97+83. Look upstream Pleasanton zone D.

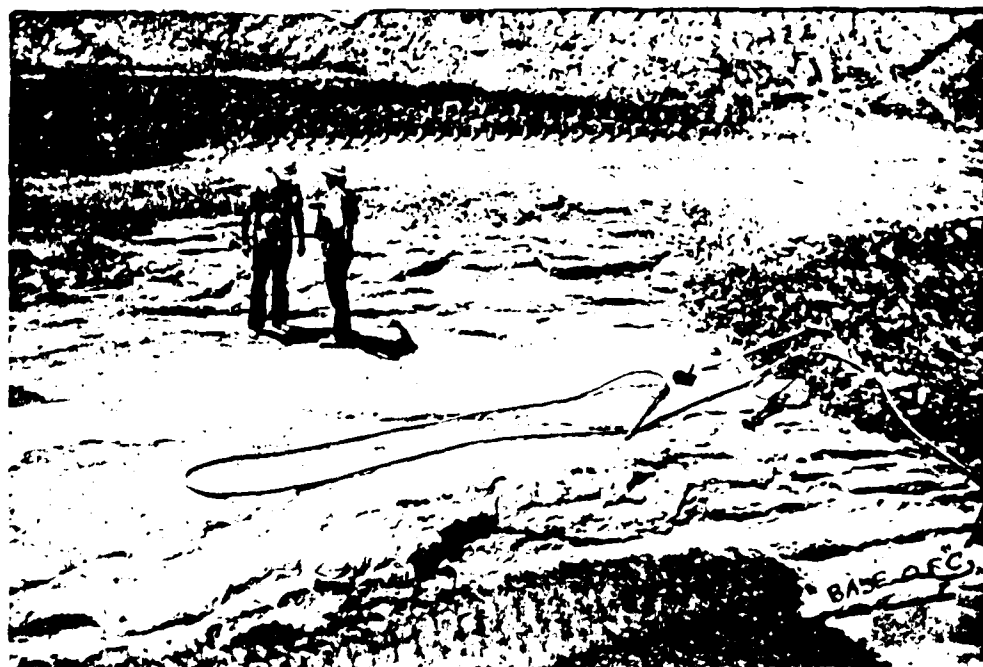
104. Longview Lake, 2 May 81, Neg. No. 652.
Station 98+70. Look west at base of Pleasanton
zone C.

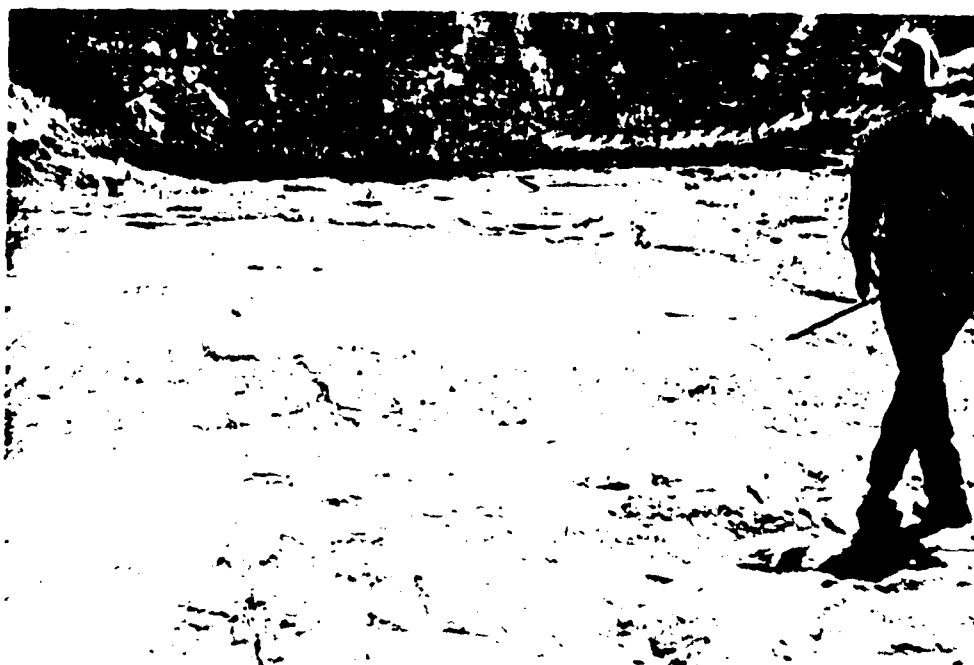
108. Longview Lake, 14 Jul 81, Neg. No. 870.
Station 98420. Look east Pleasanton zone D.

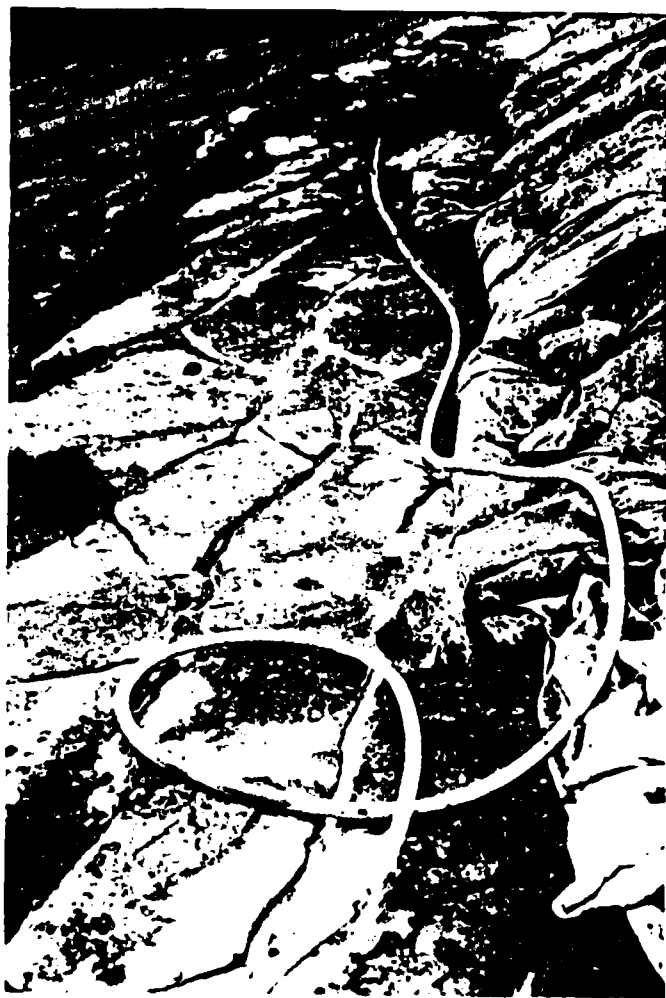
137. Longview Lake,
4 Oct 81, Neg. No. 1137.
Station 100+75, range
100' U/S. Filling joints
in Middle Creek limestone
with grout.

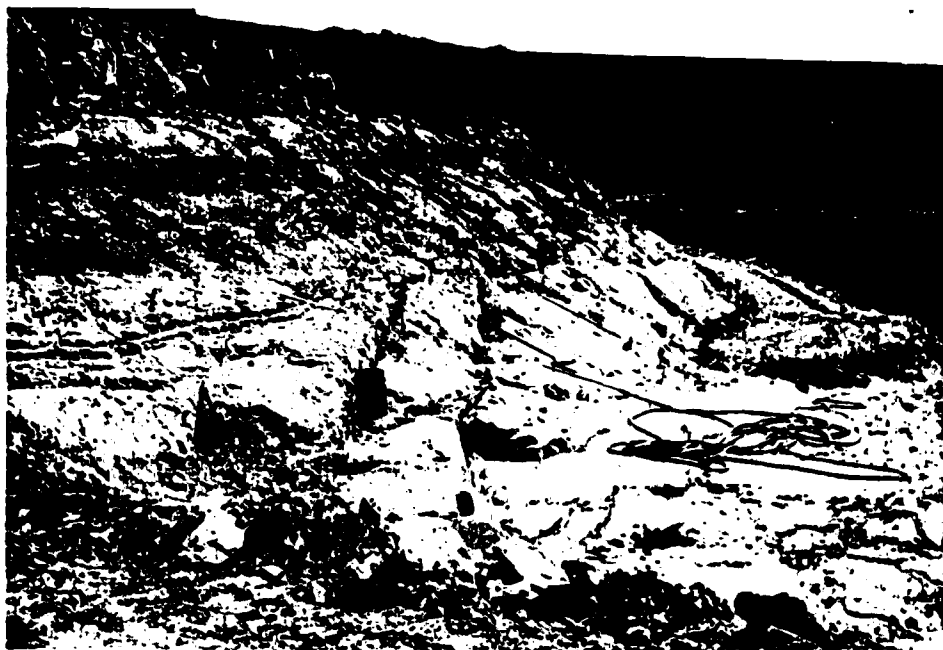
148. Longview Lake, 18 Aug 83, Neg. No. 179.
Station 88+50, range 320' D. Look U/S. Joints
in Pleasanton zone A sandstone. Strike N 12°E,
spacing 3'±.

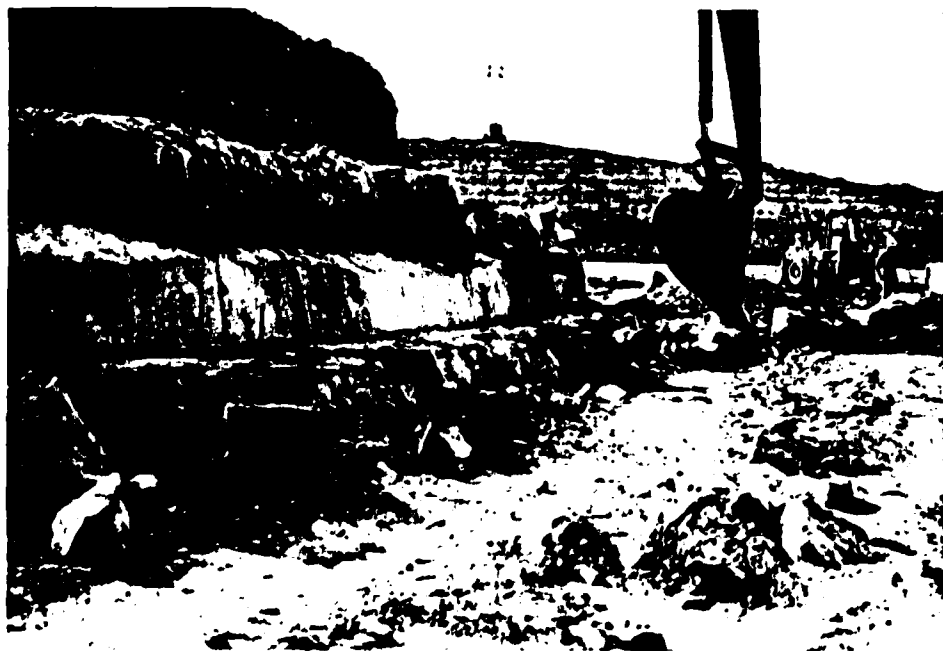
149. Longview Lake, 13 Sep 83, Neg. No. 187.
Station 88+90±, range 200'± D. Look U/S lean
concrete placed against Sniabar limestone.

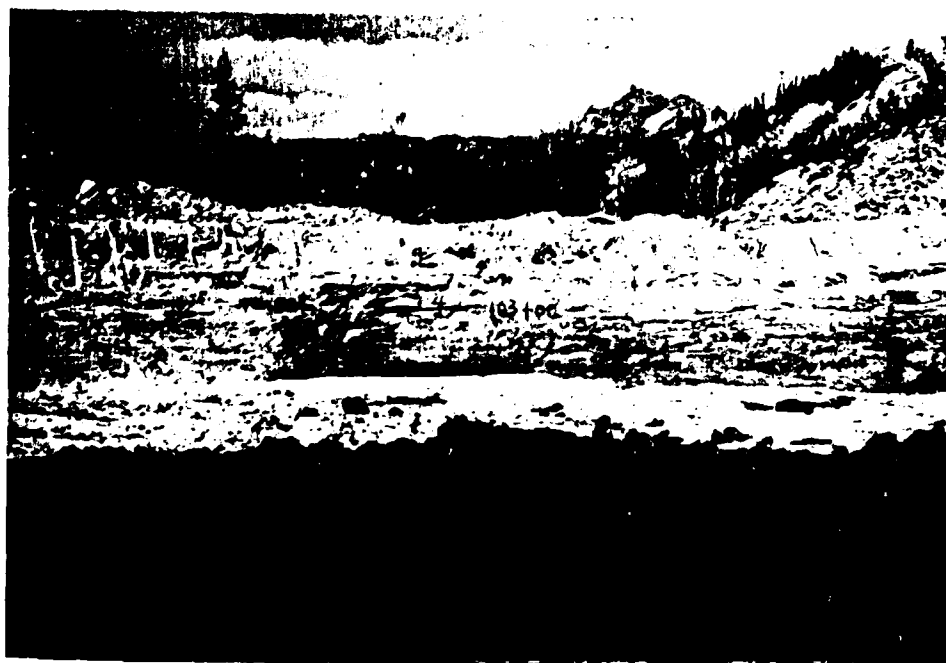
165. Longview Lake,
31 Jul 84, Neg. No. 275.
Station 87+301, range
60'±UP. Look downstream
at Stark shale.
